SUBGRADE MOISTURE VARIATIONS

INTERIM REPORT VIII

EVALUATION OF COLLECTED DATA 1966-1969

Research Project 64-01-3
Oklahoma Research Program

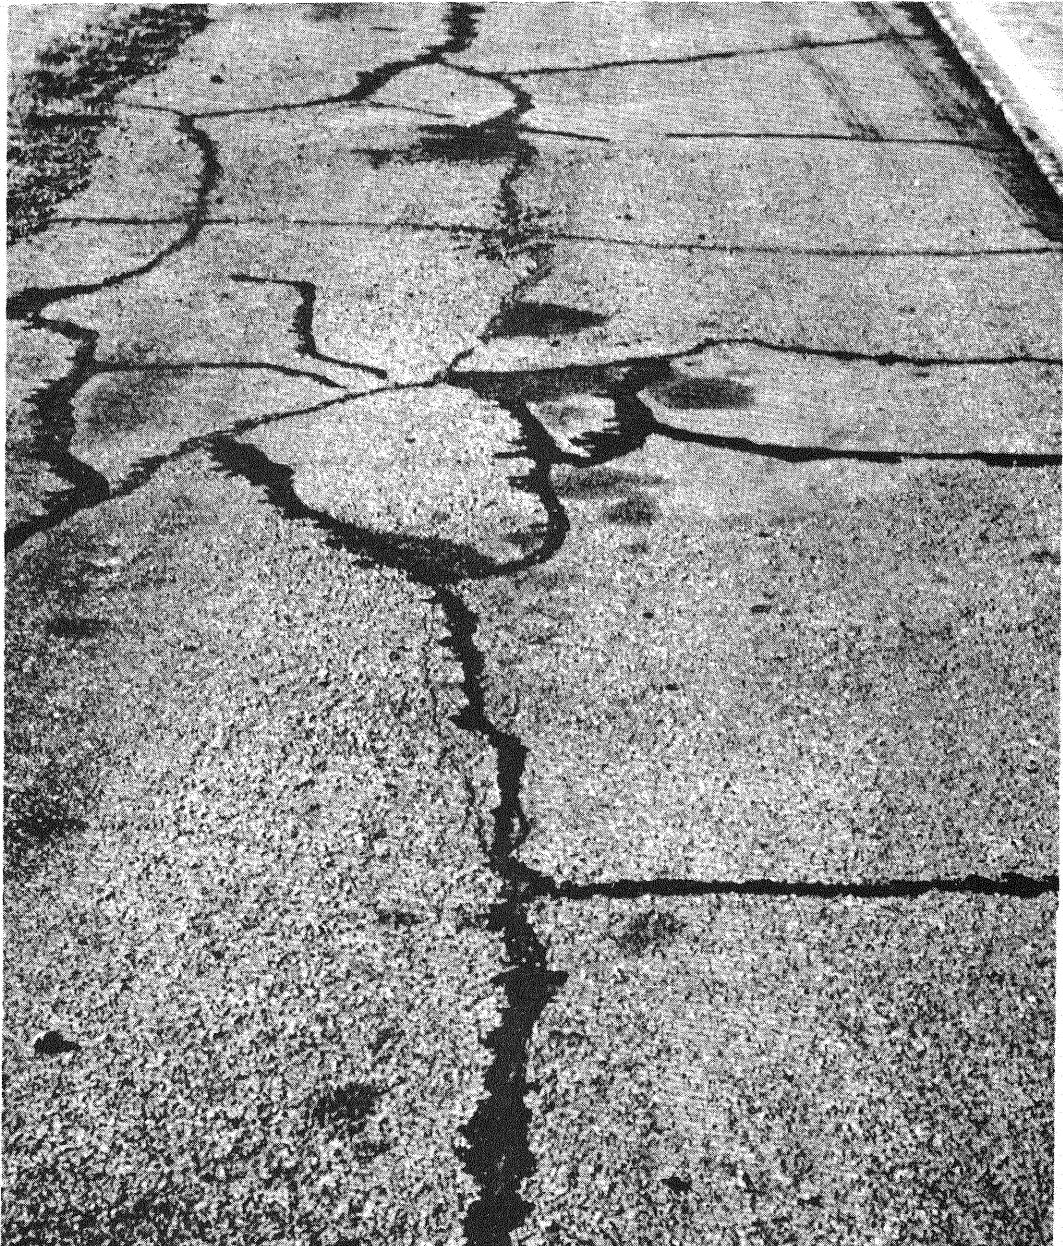
The results of lateral swelling are illustrated in Fig 5.7, a photograph of the outside shoulder of I-40 adjacent to Site No. 42 in Seminole County. This four-lane divided highway was constructed in 1965 and has PCC pavement with improved shoulders extending four feet inside and 10 ft outside the pavement, on a uniform A-7 clay subgrade with a plastic limit range of 18-20 and lineal shrinkage of 18 percent. The base material is sand-asphalt under the pavement and soil-cement under the shoulders. The outside shoulder has moved laterally away from the pavement, opening the joint between shoulder and pavement approximately one inch. The shoulder surface has also cracked extensively, in both transverse and longitudinal directions. The longitudinal cracks are within three to five feet of the shoulder edge and are probably caused by the wet-dry interface described by Dagg and Russam (Ref 6). A plot of moisture conditions under the highway at Site No. 42 for the wet and dry seasons of the year is shown in Fig 5.8, and seasonal fluctuations under the outside shoulder are more severe than under the inside shoulder or pavement centerline. Divided highways generally exhibit this type of moisture behavior because the median does not drain as well as the outside shoulder, thus most four-lane divided highways have only fair to good drainage.

Figure 5.7. Transverse and Longitudinal Cracks in Outside Shoulder
at Site No. 42

Tensile stresses in the soil-cement base material, as a result of swelling caused by increased moisture content, probably caused the shoulder cracking shown in Fig 5.7. Observation records and photographs of Site No. 42 indicate the cracks have doubled in extent and number since the summer of 1967, when first observations were made. The new cracks probably caused fluctuations before they were sealed, as shown in Fig 5.9, a plot of moisture variations under the outside shoulder at Site No. 42. It can also be seen in Fig 5.9 that, prior to sealing the cracks in the summer of 1968, moisture content had increased to well above the plastic limit range. After sealing, moisture contents were reduced to an equilibrium value with the moisture content/plastic limit ratio between 1.1 and 1.2. As previously mentioned, greater fluctuations in subgrade moisture content occur under the outside shoulder and this probably resulted in differential movements between the pavement and outside shoulder, causing the new, unsealed cracks shown in Fig 5.7.

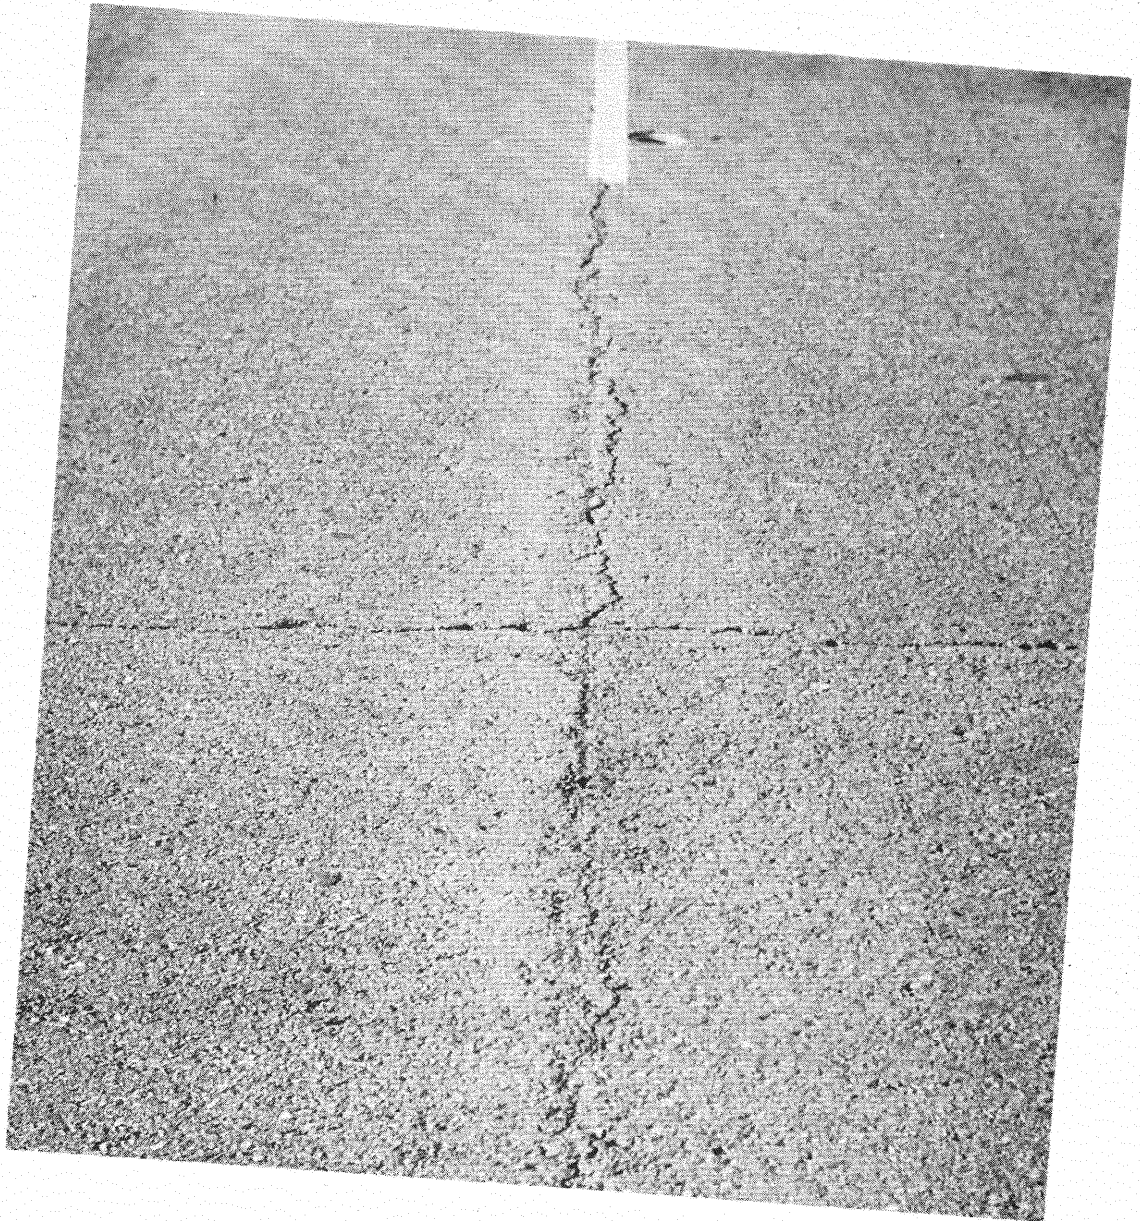
Figure 5.11 shows moisture variations and rainfall at Site No. 4, installed in July 1966. Moisture contents decrease with depth and some levels are above the subgrade liquid limit. Moisture contents had decreased when the second overlay was applied and heavy precipitation in the winter of 1967-68 caused a sharp increase in moisture contents, particularly at the 2.5 foot level. The bearing capacity was greatly reduced and in the early spring of 1968 the new overlay cracked. Since the old overlay was already cracked, infiltration occurred. Research personnel reported a "thumping" noise whenever traffic crossed the transverse joints before and after the second overlay. Much of the subgrade support was evidently lost long before 1966 when first observations were made. Figure 5.12 shows a photograph of the

Figure 5.12. Transverse and Longitudinal Cracks in Overlay at Site No. 4

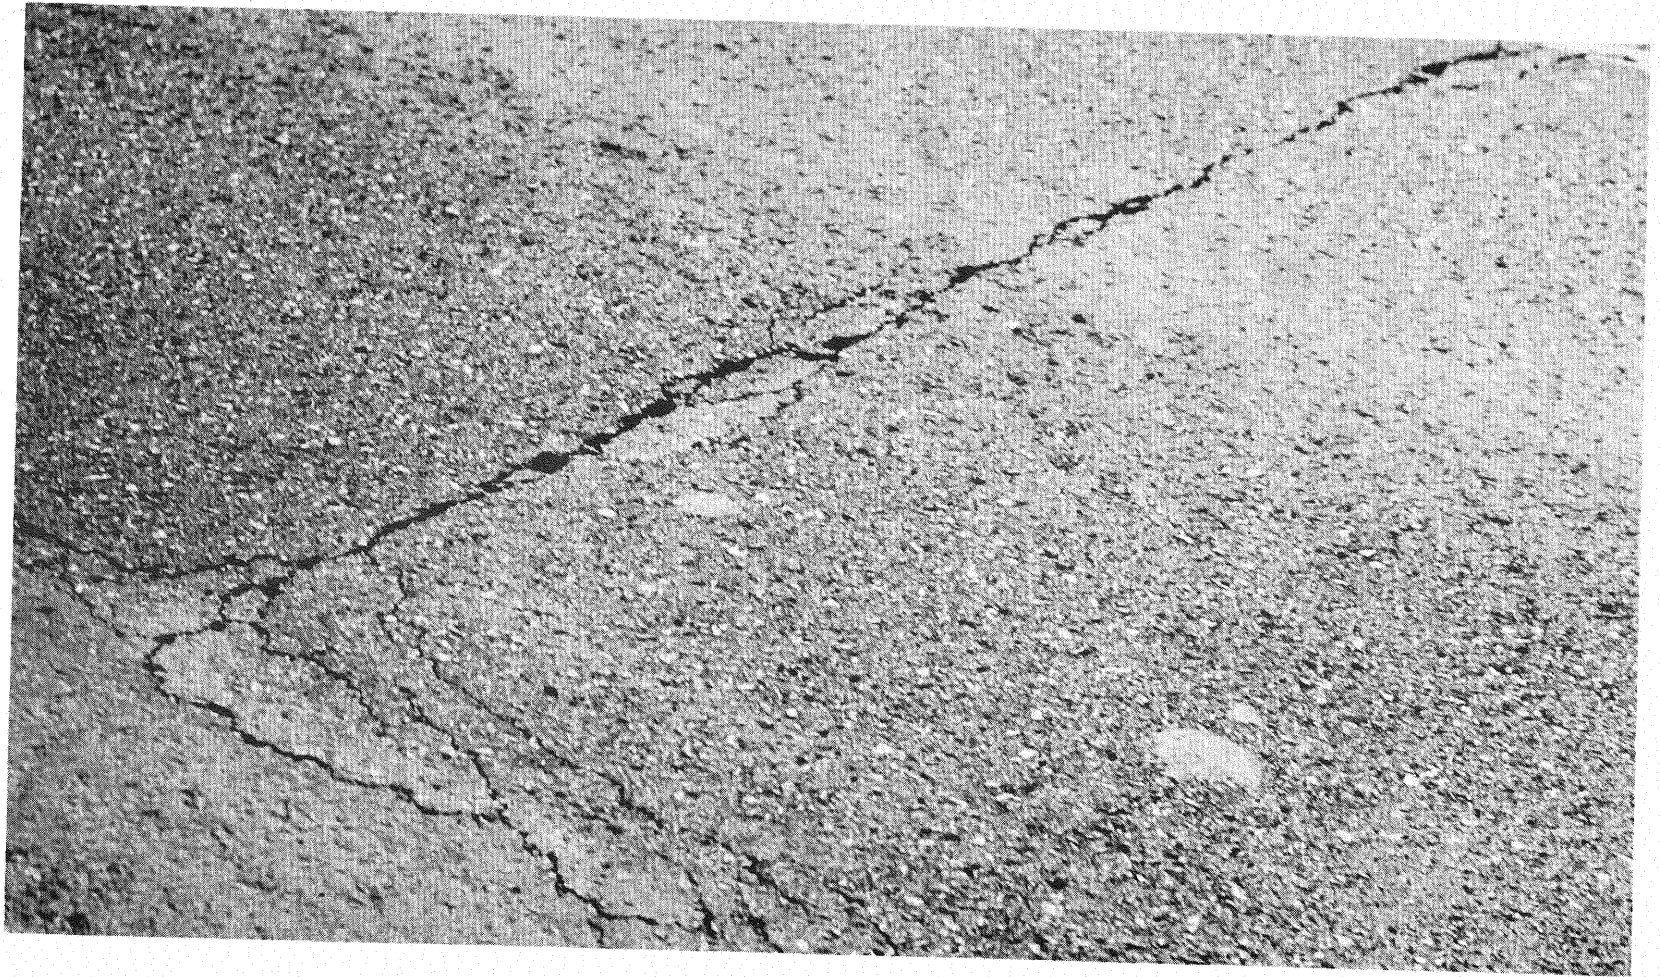
reappearance of centerline and transverse joints adjacent to Site No. 4. Details of the cracking are shown by a photograph in Fig 5.13, where the size of the transverse joint in the underlying PCC pavement is indicated by the size of the AC chunks from the new overlay. Also evident is longitudinal cracking between the pavement and the widened portion. Figure 5.14 shows the subgrade soil profile at Site No. 4. The silty layer under the pavement probably acts as a "holding basin" for infiltration into the subgrade below.

Figure 5.13. Close-up of Transverse and Longitudinal Crack Along Pavement Edge at Site No. 4

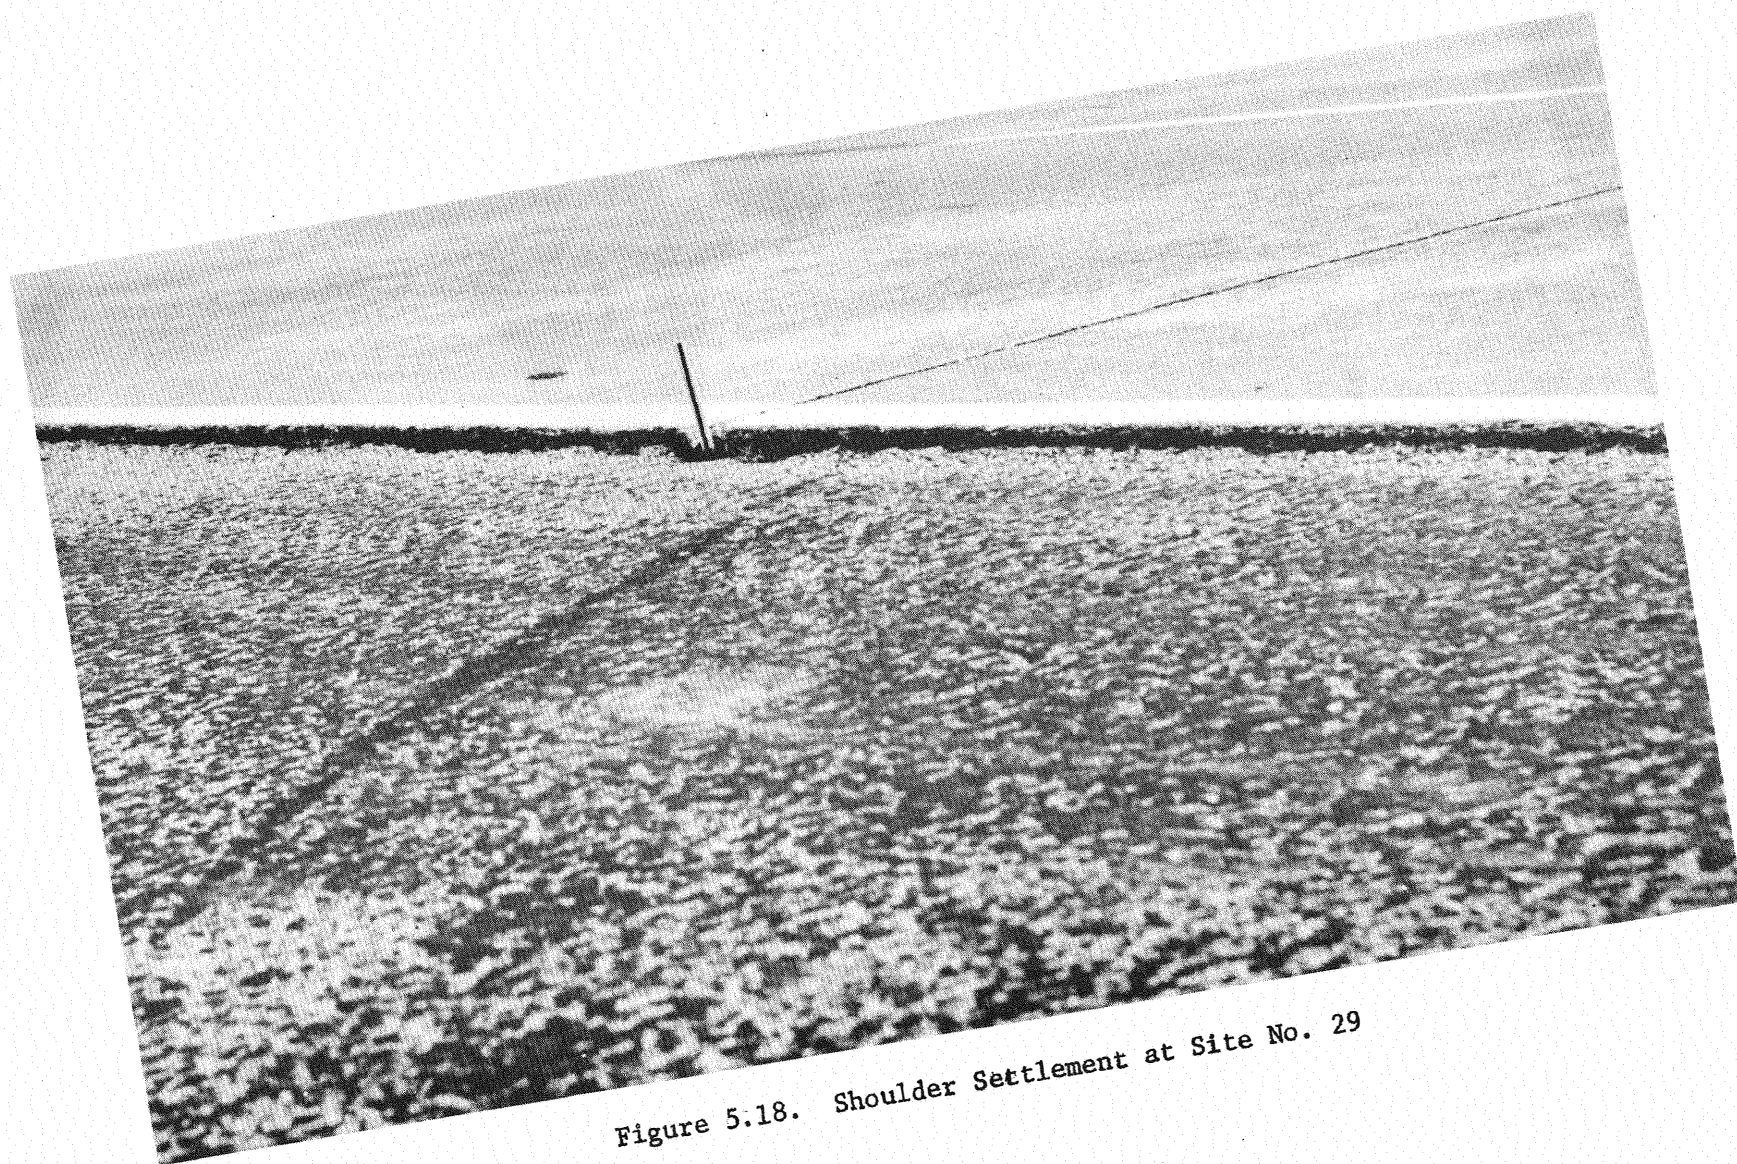
Site No. 29 is a relatively high fill section on US 64 in Tulsa County. The two-lane highway has PCC pavement with improved shoulders and was constructed in 1960 on a uniform A-7 clay subgrade with a plastic limit range of 20-28 and an average lineal shrinkage of 20 percent. Capillary water accumulates under the pavement centerline, but probably evaporates near the edge of the shoulders because of greater surface area on the embankment sides. A photograph of one shoulder at Site No. 29 is shown in Fig 5.18. This shoulder has settled 2 to 3 inches, as has the other shoulder, because of generally dryer conditions under the shoulders. Figure 5.19 is a photograph of the pavement edge at Site No. 29. The ripples in the pavement edge are probably at joints, since a transverse joint usually coincides with

Figure 5.18. Shoulder Settlement at Site No. 29

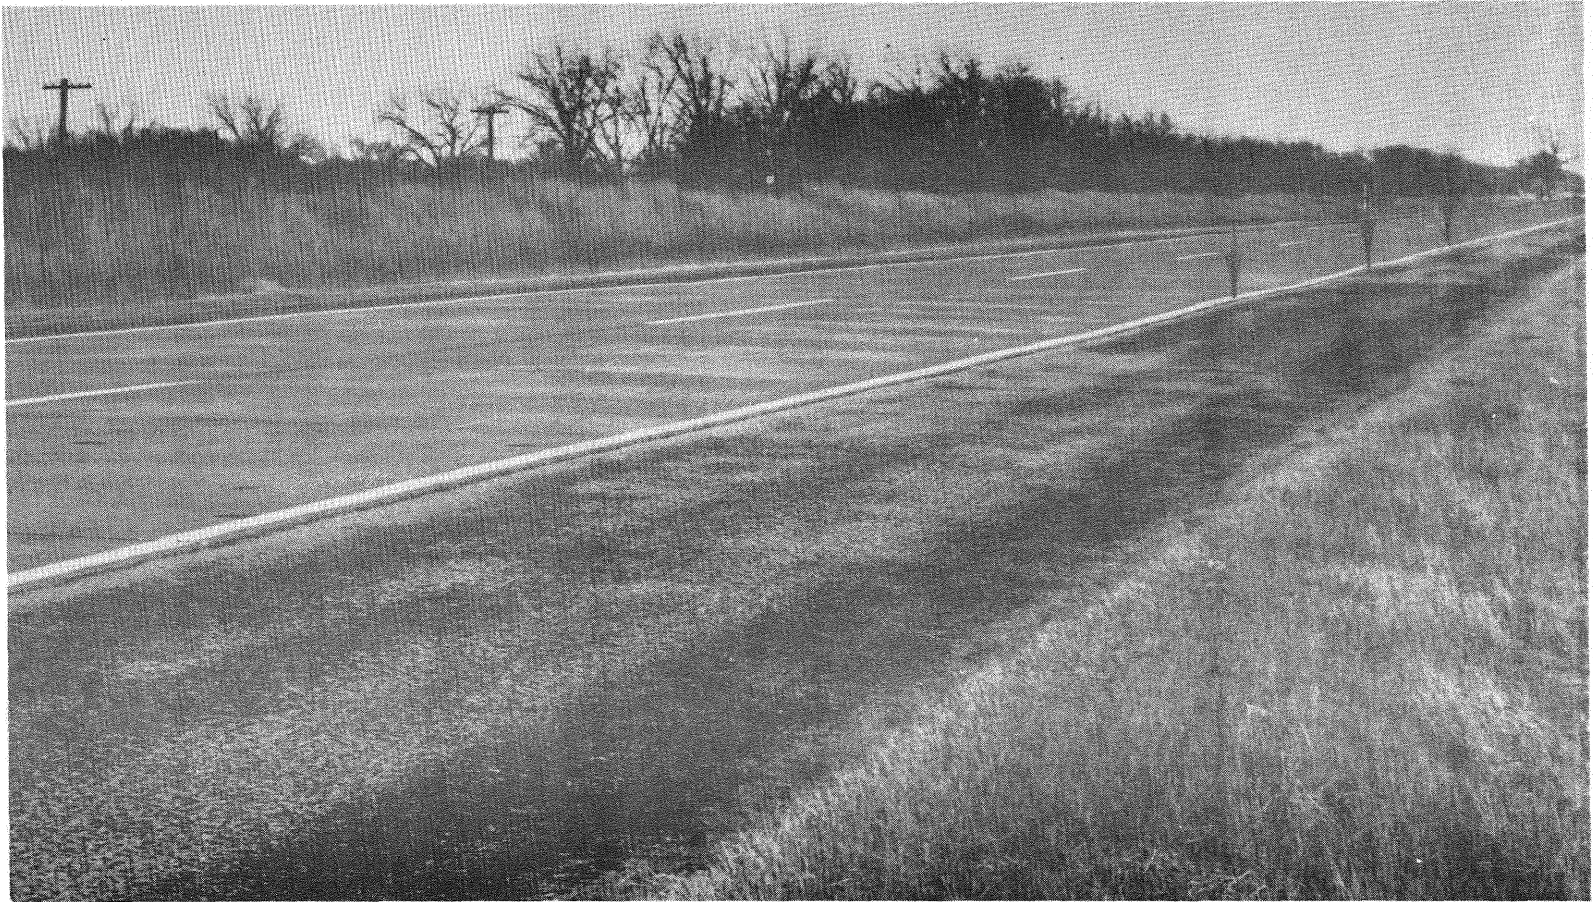
Figure 5.19. Ripples in Pavement Edge at Site No. 29

the peak of a ripple. Pavement and shoulder ratings at Site No. 29 are good.

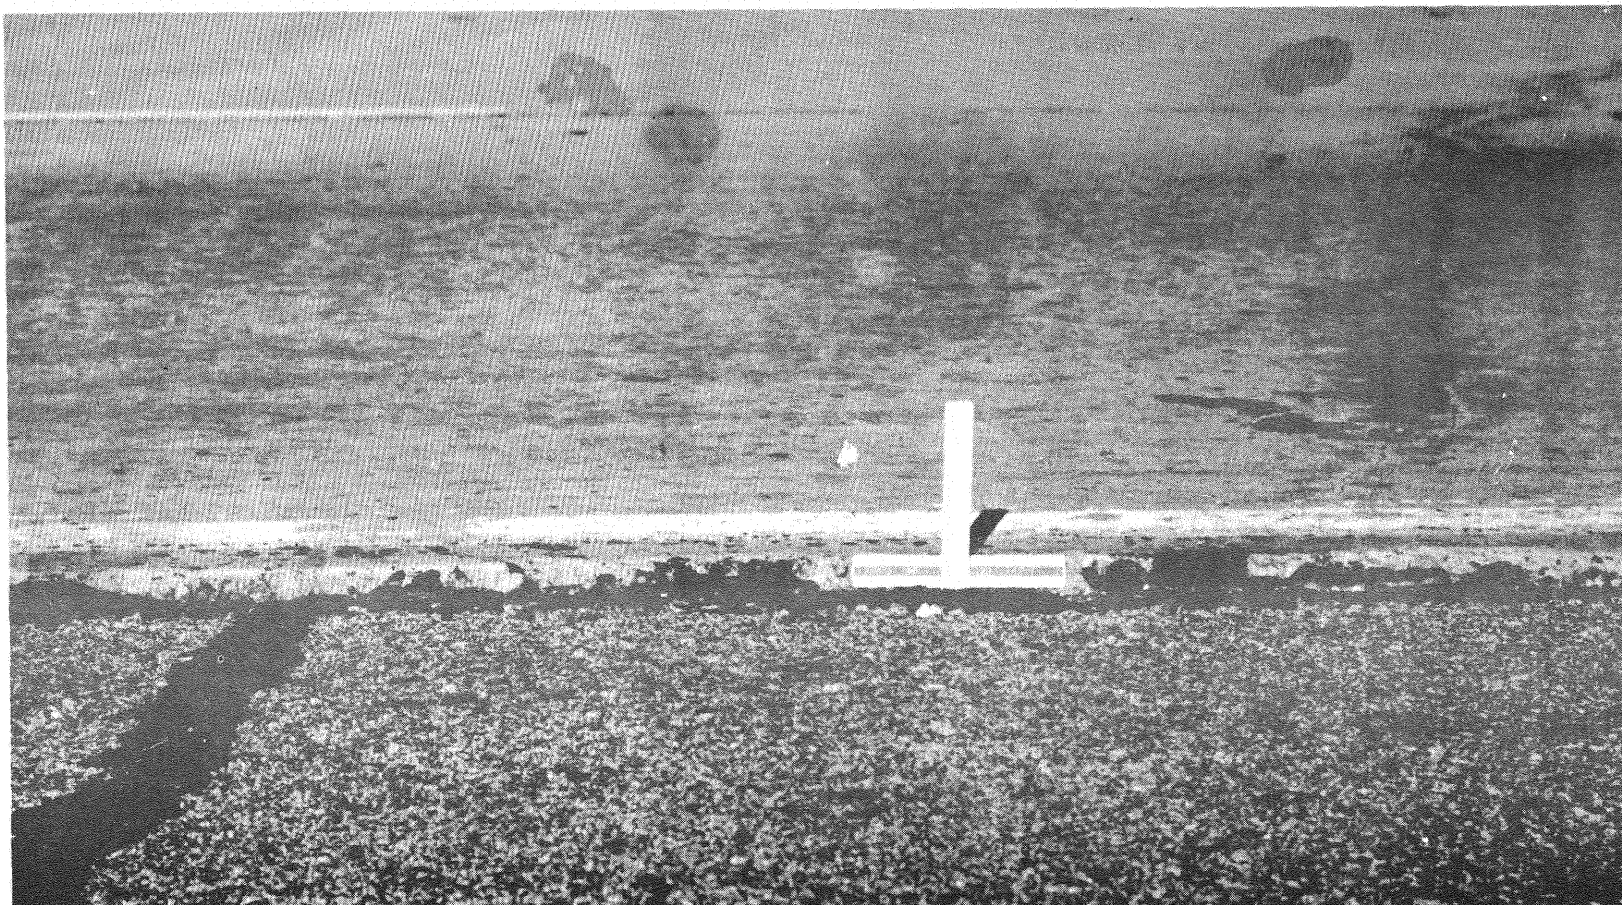
Subgrade soil type was found to be related to subgrade moisture behavior. Data from sites with bench marks indicates plastic and non-plastic subgrade soils swelled with increasing moisture content, although the plastic subgrade soils swelled more. Most plastic subgrade soils exhibited an average heave/moisture content increase ratio of 1/12 in./% as compared to less than 1/16 in./% for "good" non-plastic subgrade soils. Figure 5.21 is a picture of the shoulder adjacent to Sites No. 49 and 50. As mentioned previously, Site No. 49 is AC pavement with a sand-asphalt base under the shoulders, while Site No. 50 has PCC pavement with soil-cement base under the shoulders. The sites are within 50 yds of each other, though they have different subgrades. The plastic subgrade soil at Site No. 50 heaved four times as much as the "good" subgrade at Site No. 49. It is readily apparent that the soil-cement base has been cracked as a result of this swelling while the sand-asphalt base did not crack. Before the cracks were sealed moisture content increased considerably under the shoulder at Site No. 50. Close scrutiny of Fig 5.21 will show longitudinal cracking near the shoulder edge of the section with soil-cement base, which

Figure 5.20. Shoulder Settlement at Site No. 42

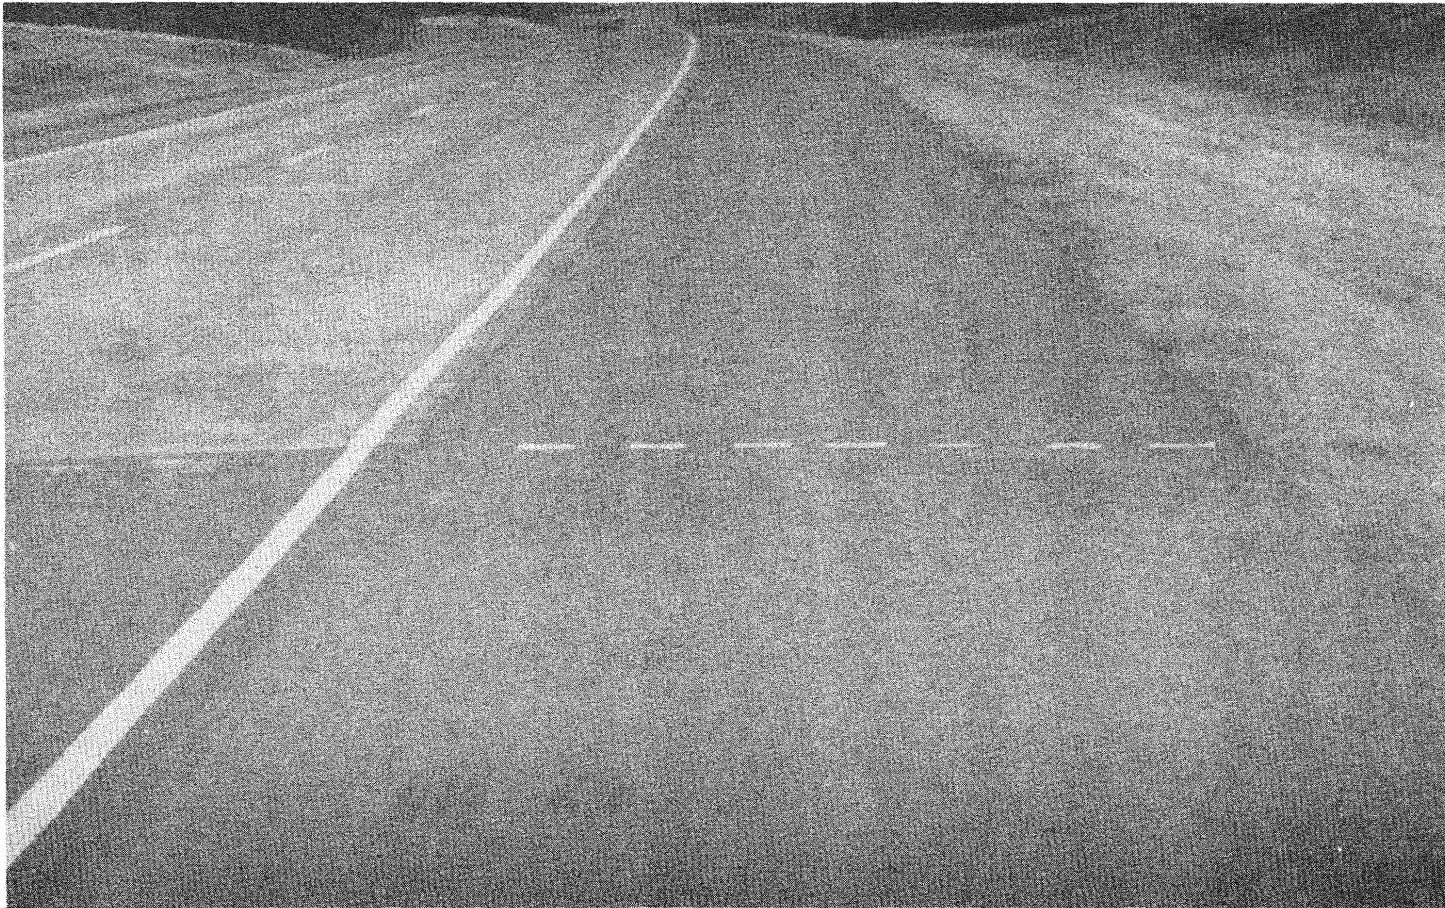
Figure 5.21. Shoulder Cracks Adjacent to Site Nos. 49 and 50

was probably caused by development of a wet-dry interface.

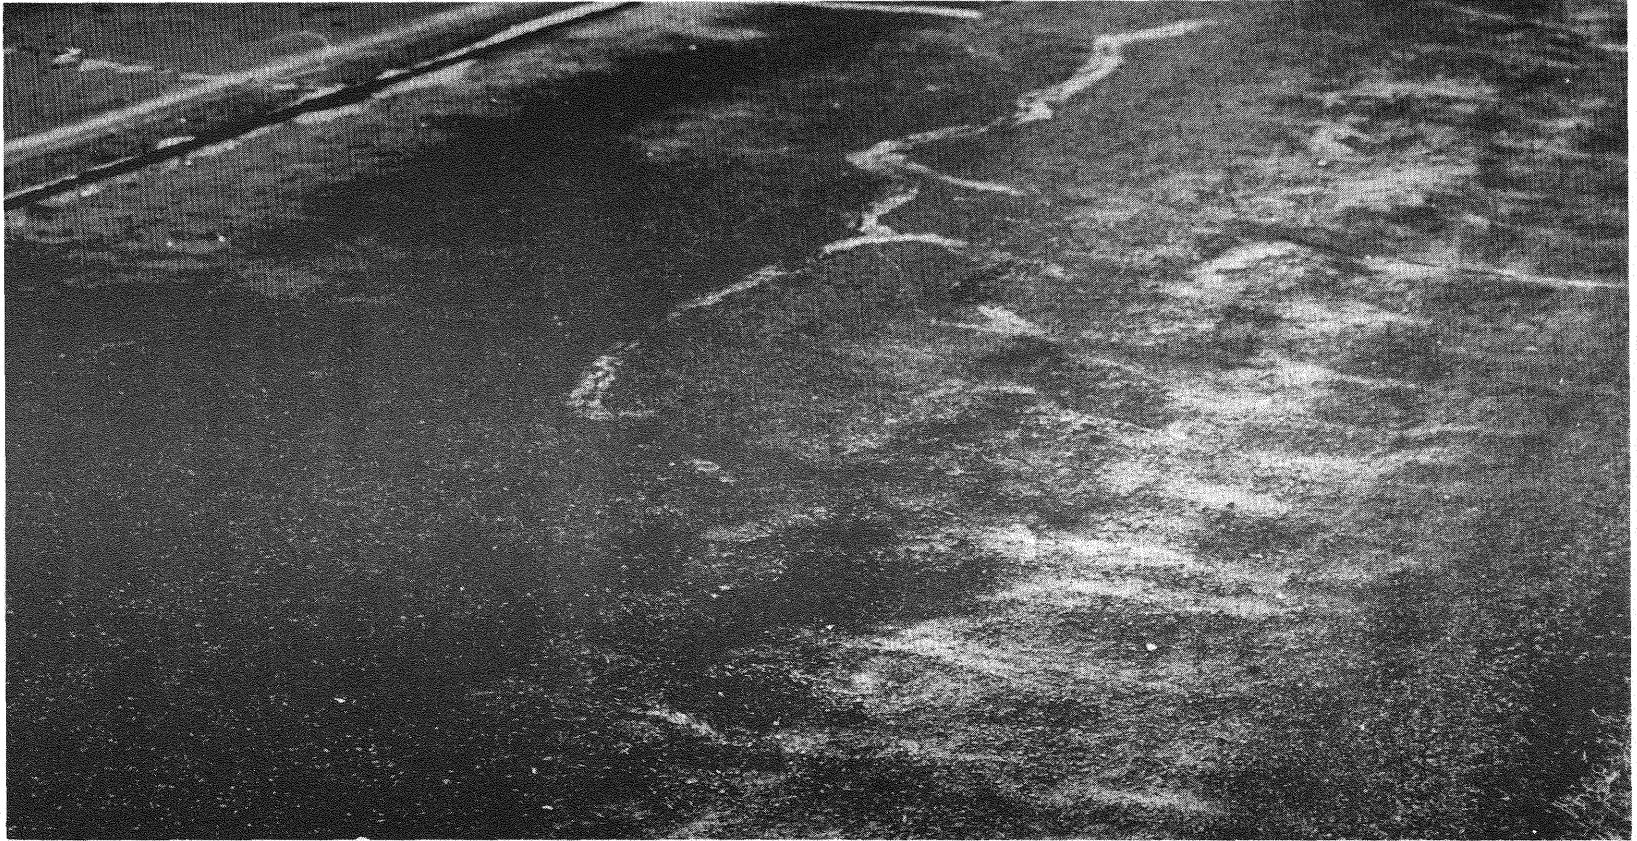
Figure 5.23. Shoulder Failure Because of Heavy Traffic

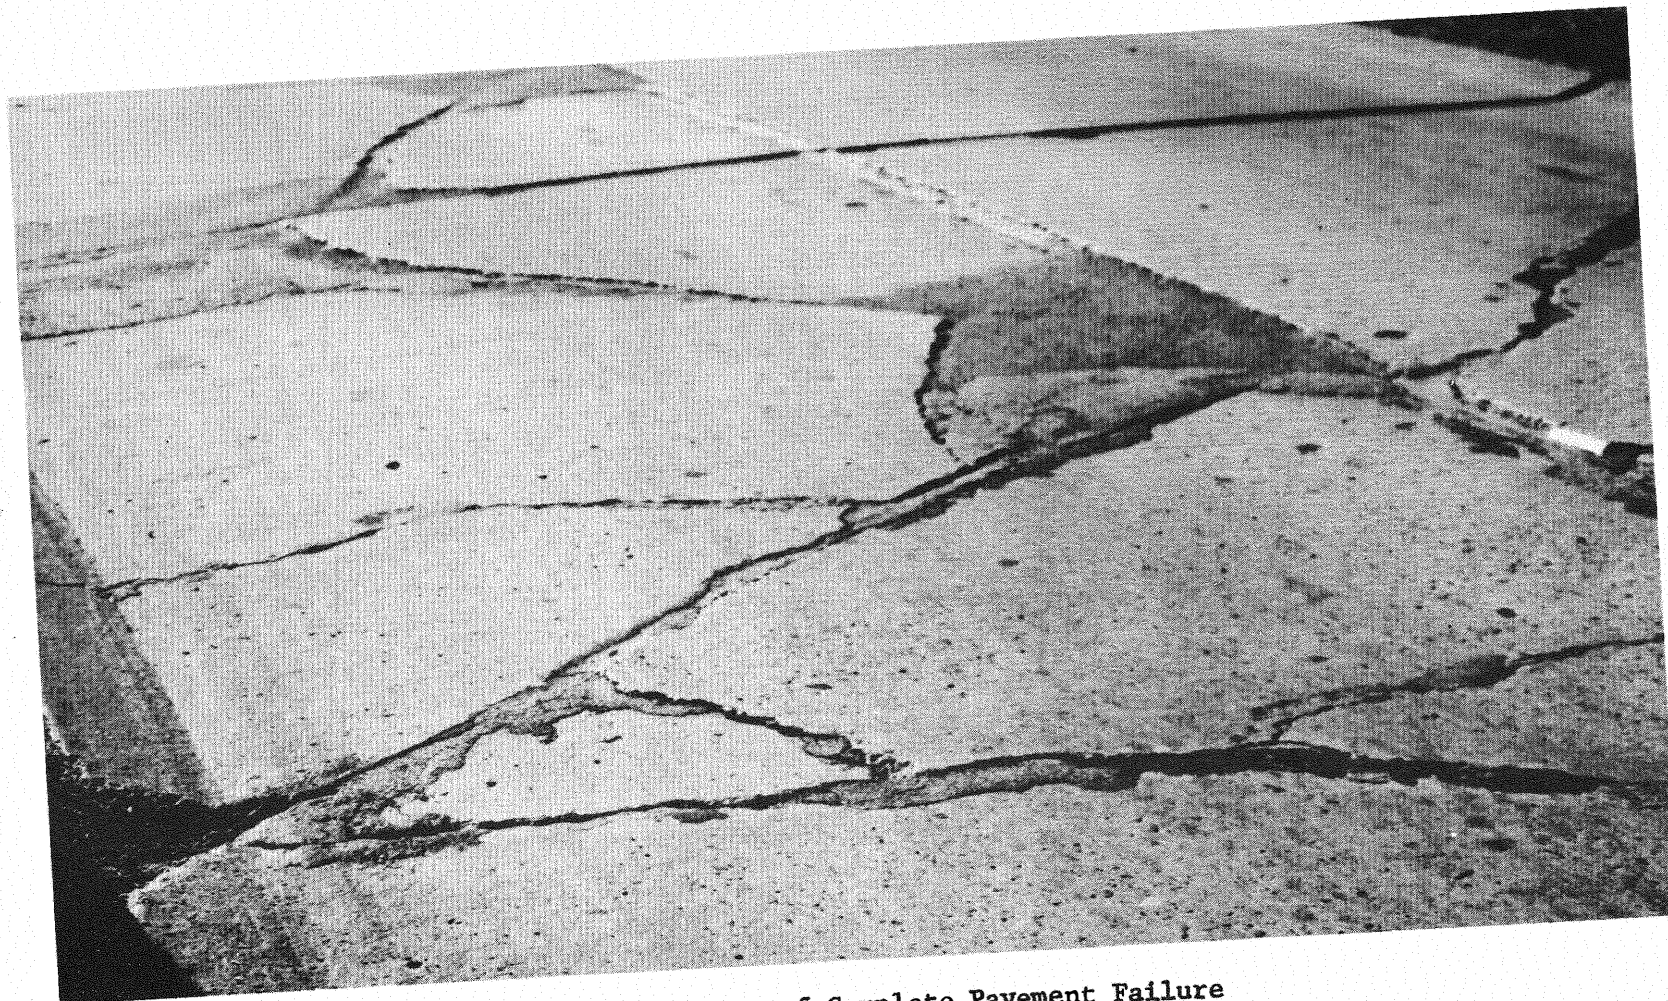
As noted previously, concrete pavements grow because of thermal expansion. Upon contraction, joints are wider since only each slab contracts. If the widened joint is not sealed, solid material fills the joint. Upon the next expansion/contraction cycle, the total "growth" is greater because the joints have been filled. As the joints become wider, greater amounts of infiltration occur, causing the subgrade soil to swell and this swelling opens the joints still further. When subgrade moisture contents are high enough, pumping may occur, and the pavement fails because of reduced bearing capacity and loss of subgrade support. Figure 5.24 shows a pavement which has failed completely because of swelling soils and improper maintenance of the joints. Figures 5.25 and 5.26 show details of wide joints, differential movement along the pavement centerline, and pavement cracking. Nearby is the subgrade for the new replacement highway, which has

Figure 5.24. Overall View of Complete Pavement Failure

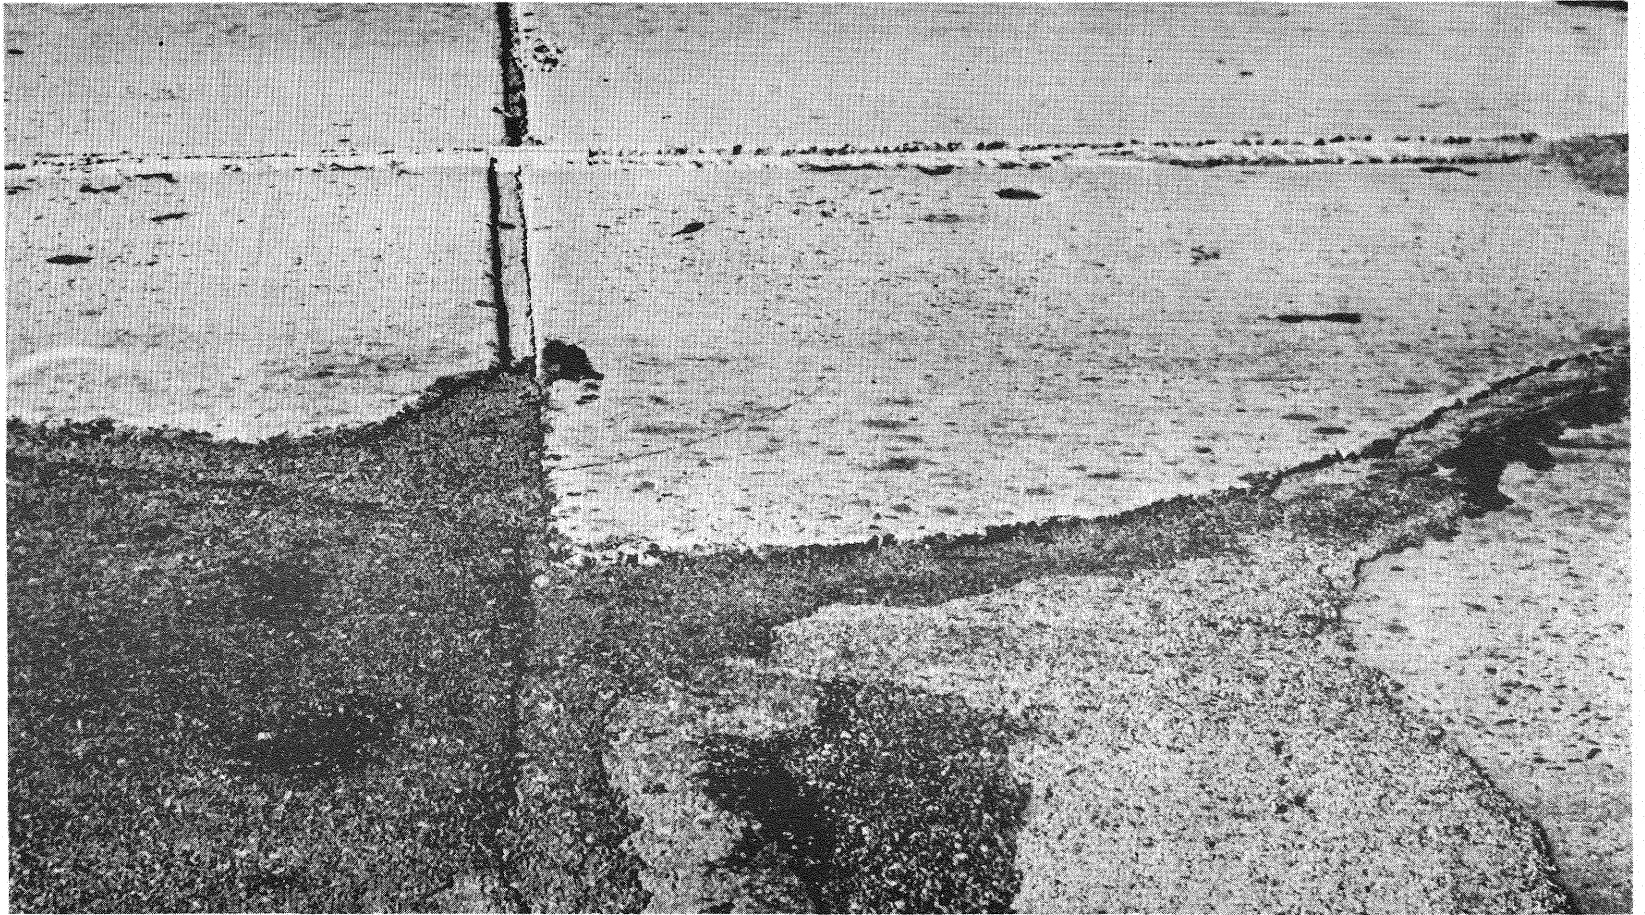
Figure 5.25. Close-up of Cracks and Joints in Figure 5.24

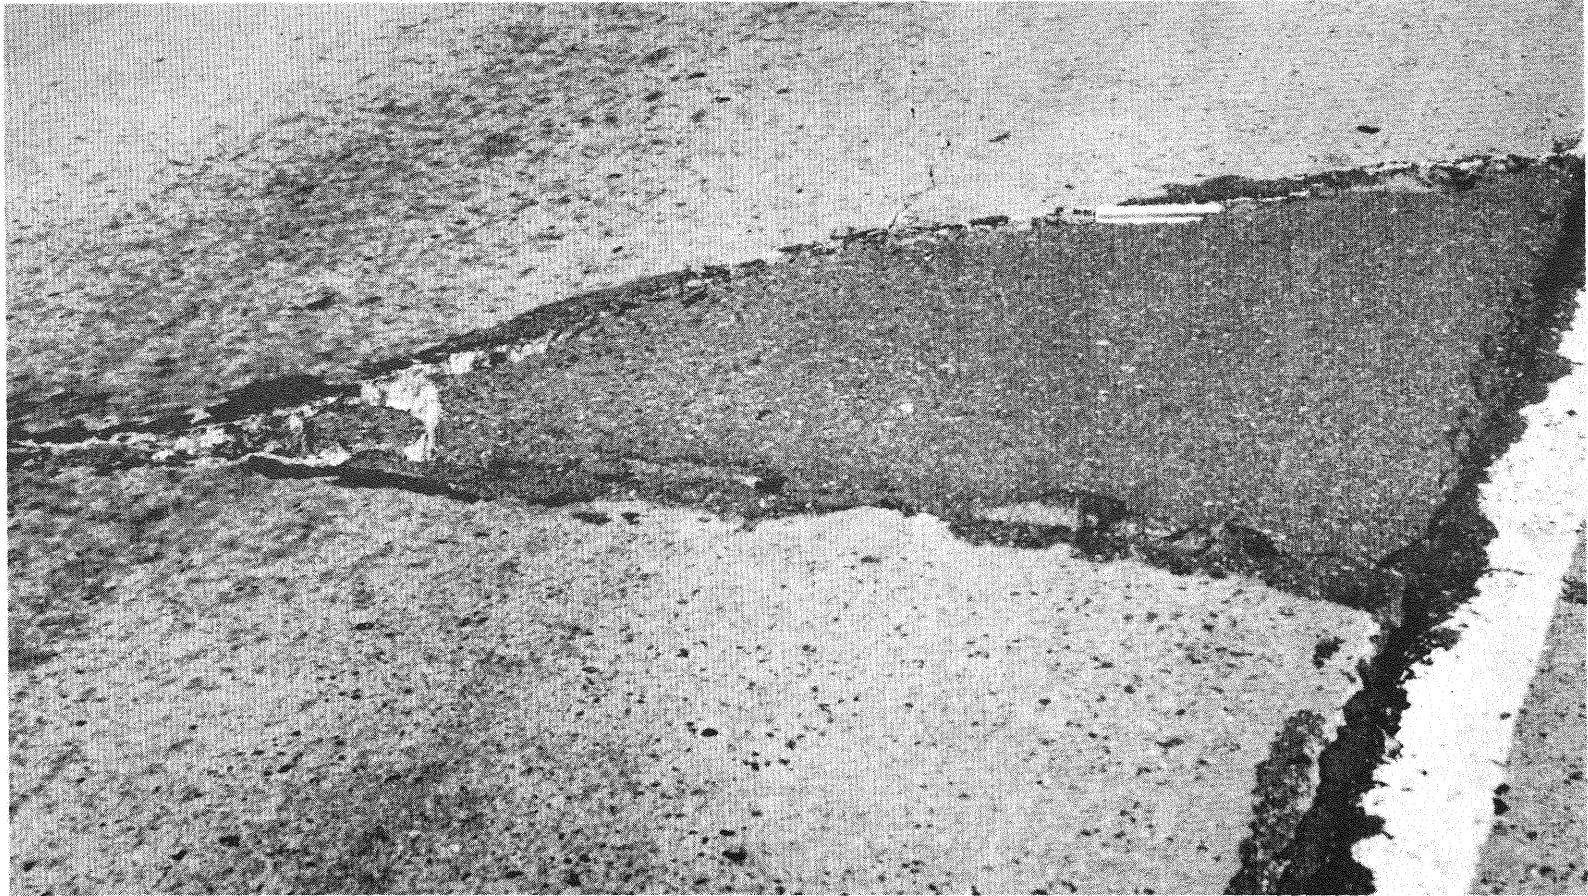
Figure 5.26. Open Centerline Joint and Corner Crack
